FACILITY COMPLIANCE INSPECTION REPORT

Division of Waste Management Solid Waste Section

Date of Site Inspection: April 9, 2013 **Date of Last Inspection:** January 24, 2013

Columbus County LCIDLF
Landfill Road
Whiteville, North Carolina 28472

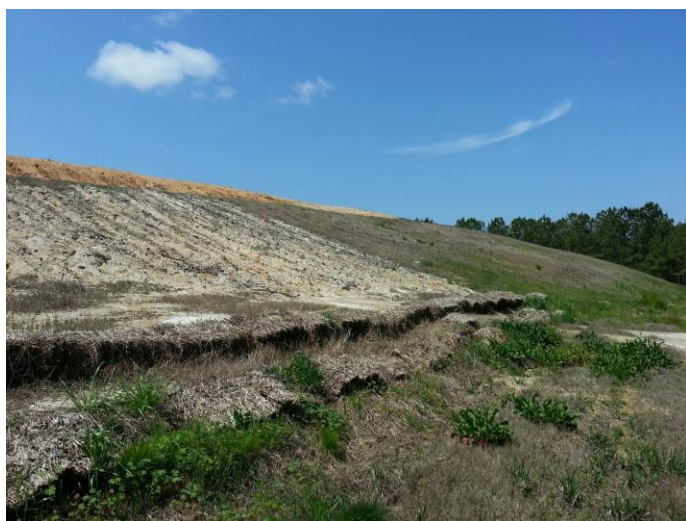
7. There was soil erosion along the northwest corner of the side slope. Soil will need to be placed and vegetation established so as to provide adequate cover. Erosion control measures are being utilized, with no offsite sedimentation noted.

Erosion on the northeast corner

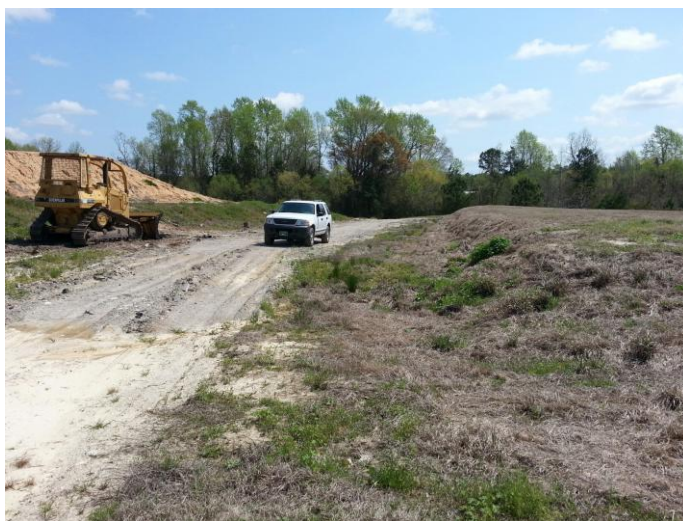
8. There was a low area across from the working face and along the haul road that appeared to have ponded water in the recent past. This area needs to be graded so as to allow proper drainage.

Low area across from the working face, along haul road
